MERRIMACK RIVER BASIN
WILTON, NEW HAMPSHIRE

SOUHEGAN RIVER WATERSHED
DAM NO. 33
NH 00265
NHWRB 254.34

PHASE I INSPECTION REPORT
NATIONAL DAM INSPECTION PROGRAM

AUGUST 1979

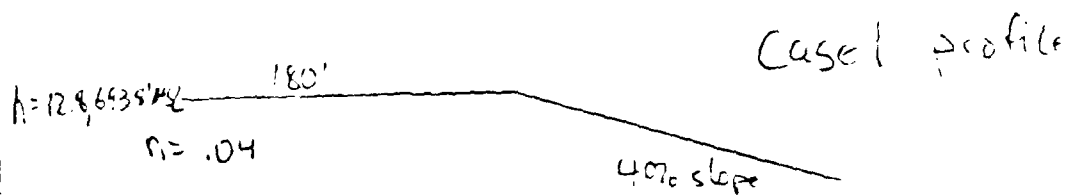
Cross-section:

The SCS also calculated the Stage-Discharge relationship for the emergency spillway assuming a crest width of 120 ft. The final design crest width is 102 ft, so we will redo the calculation. The profile of the spillway section is as follows,

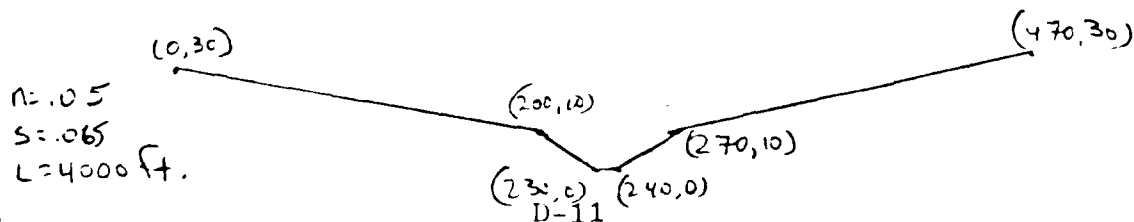
Below Dale St., the brook runs about 4000 ft. to feed into Stony Brook. The primary development in this reach is New Hampshire Highway 31, which crosses the brook just before it enters Stony Brook, and a house about 150 ft. upstream of the highway 6 ft. above the streambed. The following typical cross-section for this reach is based on field notes and USGS topo information.

The Stage - Normal Flow relationship for this reach is given on p. 14. The pre-failure flow of 414 cfs would create a stage of 2.3 ft. in this reach. The attenuation due to storage in the reach is calculated on p. 15. The attenuated peak dam failure flow at the confluence with Story Brook would be 6880 cfs, which would create a stage of 8.7 ft.

The house 150 ft. upstream of Highway 31 is 6-7 ft. above the streambed. Thus the peak dam failure flow would increase flooding from none to 2-3 ft. at this location. There would be some danger of loss of life at this location.

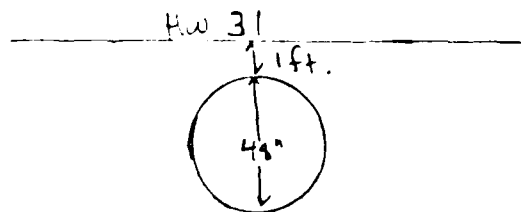
Highway 31 crosses the brook on an embankment with a 48" conduit:

According to FHWA "Hydraulic Engineering Circular No. 5," this culvert could carry about 80 cfs with the water surface at the roadway. Thus, before failure $414 - 80 = 324$ cfs would flow over the road. After failure this would increase to about $6880 - 80 = 6800$ cfs. This volume of flow, at the high velocities involved, would probably severely damage or destroy the embankment, rendering Highway 31 useless until repairs could be made.

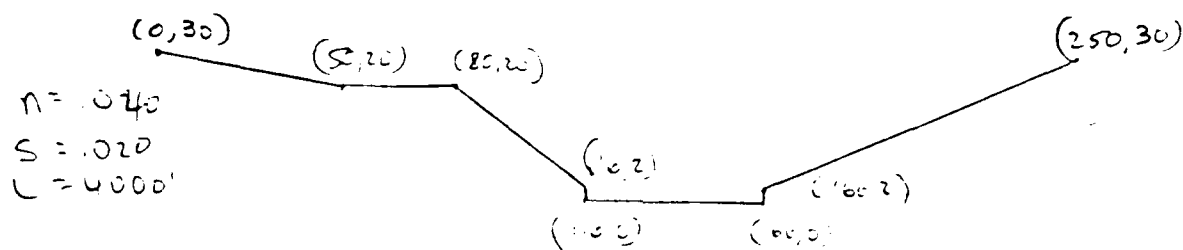
For the next 4000 ft. to the town of Wilton, Stony Brook is paralleled by Highway 31. There is no other development in this reach. The following typical cross-section is based on field notes and U.S.G.S. topo information.

The Stage-Normal Flow relationship for this reach is given on p. 17. The pre-failure flow of 900 cfs (assuming 2500 cfs inflow from Stony Brook) would create a stage of 2.1 ft. The attenuation due to storage in this reach is calculated on p. 18. The attenuated peak flow of 6,550 cfs yields a stage of 7.4 ft, which would not reach the highway. This flow does not include any assumed inflow from Stony Brook, which would make dam failure flows higher and increase downstream damages. If the inflow is on the order of 500 cfs, this increase would not be large.

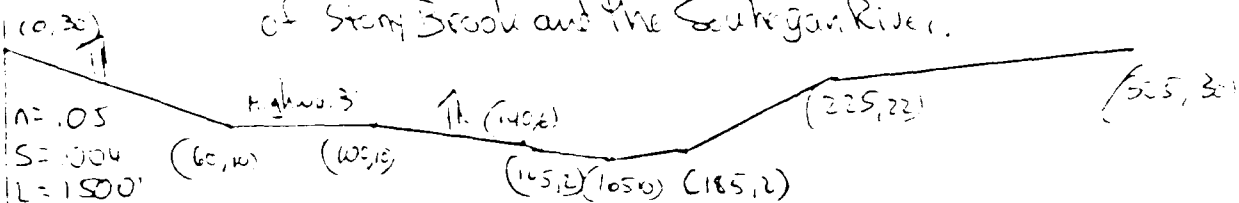
about 12' above the streambed and a laundry about 10 ft. up. Across Highway 31 there are numerous (20+) houses and businesses about 25 ft. above the streambed. The cross-section for this reach given below is based on field notes and U.S.G.S. top information. This reach runs 1500' to the confluence of Stony Brook and the Souhegan River.

The stage-Normal Flow relationship for this reach is given on p. 20. The pre-failure flow of 900 cfs would create 5.5 ft. of flow in the channel. The attenuation due to storage in this reach is calculated on p. 21. The attenuated peak failure flow of 6250 cfs yields a stage of 13.1 ft.

The failure of SRW Dam #33 would increase flooding from none to 1-6 ft. at the 9 low-lying houses. It would also cause 1 ft. of flooding at the apartment building, and 3 ft. at the laundry. This would present a serious threat of loss of life, especially in the houses. It would also flood and possibly damage Highway 31 in this area. Downstream of the residences and still in the town of Wilton, Stony Brook passes over Abbot Memorial Trust Dam and flows into the Souhegan. The resulting flow
